DEPARTMENT OF TRANSPORTATION**DIVISION OF ENGINEERING SERVICES**

Quality Assurance and Source Inspection

Contract #: 04-0120F4Cty: SF/ALA Rte: 80 PM: 13.2/13.9File #: 1.28**WELDING INSPECTION REPORT****Resident Engineer:** Casey, William**Address:** 333 Burma Road**City:** Oakland, CA 94607**Report No:** WIR-027499**Date Inspected:** 23-Apr-2012**Project Name:** SAS Superstructure**OSM Arrival Time:** 700**Prime Contractor:** American Bridge/Fluor Enterprises, a JV**OSM Departure Time:** 1730**Contractor:** American Bridge/Fluor Enterprises, a JV**Location:** jobsite**CWI Name:** Steve McConnell**CWI Present:** Yes No**Inspected CWI report:** Yes No N/A**Rod Oven in Use:** Yes No N/A**Electrode to specification:** Yes No N/A**Weld Procedures Followed:** Yes No N/A**Qualified Welders:** Yes No N/A**Verified Joint Fit-up:** Yes No N/A**Approved Drawings:** Yes No N/A**Approved WPS:** Yes No N/A**Delayed / Cancelled:** Yes No N/A**Bridge No:** 34-0006**Component:** SAS project**Summary of Items Observed:**

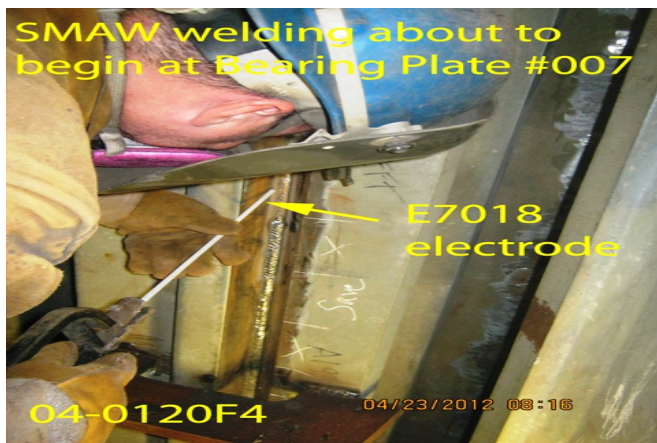
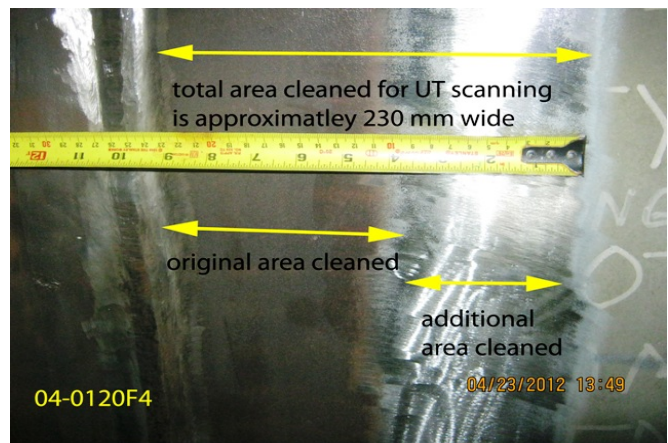
At various location around the tower at both the 3-meter and 9-meter elevations this QA Inspector randomly observed ABF personnel using hand held power grinders with sanding pads to contour weld profiles and /or clean the base material, removing paint, for Ultrasonic Testing (UT) purposes. This QA Inspector observed approximately 230 mm out from the toe of the welds were cleaned; this appeared to provide a clean scanning surface for the 80 mm thick material. See photo below of the original area cleaned for UT and the additional area cleaned.
